# Spreaders Update for RS800 AGM 30 Nov 2020

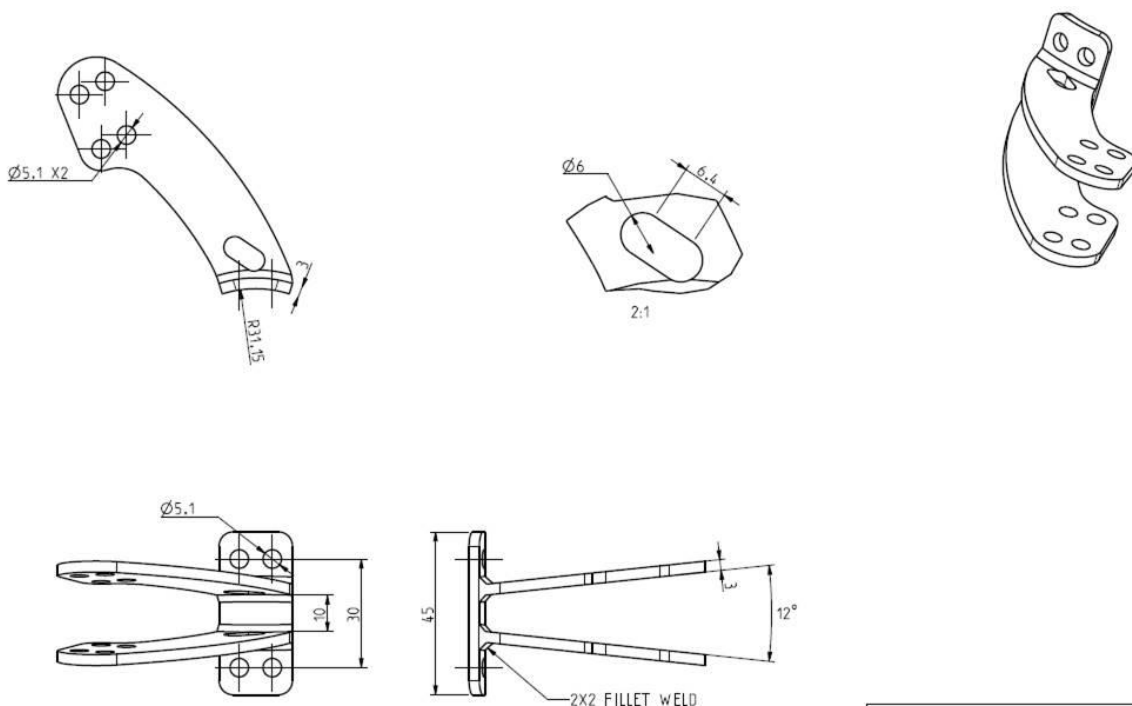
A limited production run of new mast brackets and spreaders was made to enable all faulty spreaders to be replaced. This has been completed. Testing retro fitting the new brackets to existing spreaders and older masts showed that the hole placement for the new brackets needed to be improved to ensure correct fitment. This has resulted in the new spreader bracket design below.

The 4 holes in the bracket where the spreader attaches allow good fitting to existing and new spreaders, only 2 holes will be used on each side. A production run of this new bracket has been ordered to provide stock for Selden and RS.
