RS400 - 2:1 Main Halyard

Avoid the Chafe

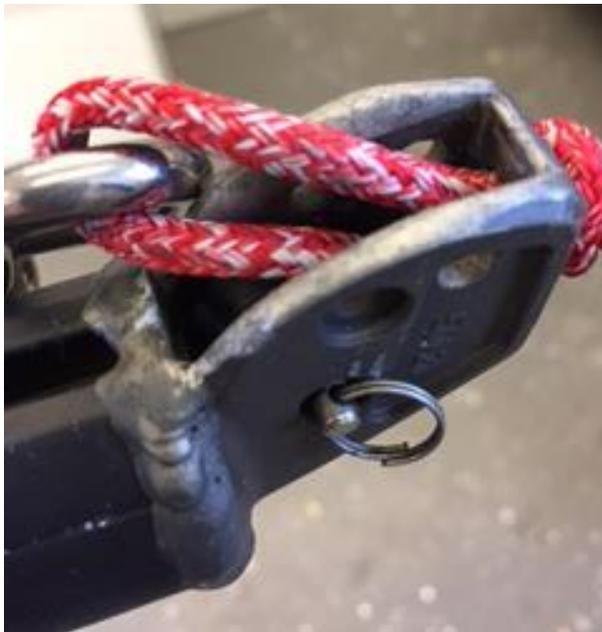
However, the edges of the head fitting are fairly sharp and fray the halyard particularly when the sail is eased, as in the left-hand picture below. As can also be seen in the picture the solution is to round off the inner edges using a file and abrasive paper.

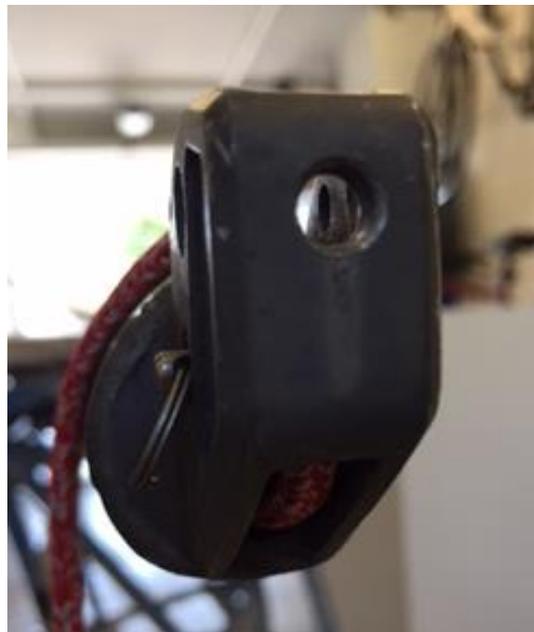
Dead ending the halyard by drilling a 5mm hole in the top of the head fitting gives an even pull and removes another potential chafe point. Use the tip of a 7mm drill to put a small countersink on the **top** and **underside** of the hole to remove the sharp edges, this is just visible in the right-hand picture above.

It is still worth periodically pulling through about 50mm of halyard and retying the dead end with a figure of eight knot at the top of the mast. This eliminates the risk of the Dynema halyard breaking due to fatigue around the shackle and also moves the wear point in the cleat.
